Cochlear™ Osia®

Magnetic Resonance Imaging (MRI) Guidelines

This guide applies to the Cochlear™ Osia® OSI200 Implant. It is intended for:

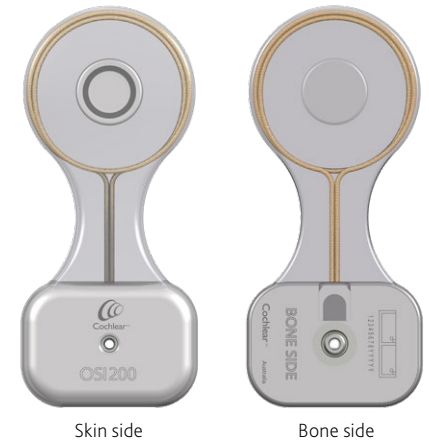
Fig. 2 OSI200 Implant (P1170466)

Cochlear Osia OSI200 Implants are made of metal and implanted under the skin behind the ear. Using an X-ray, the implant can be identified by its shape and the shape of the actuator unit.

Use the Fig. 1 and the Fig. 2 to assist with identifying the differences between Cochlear Osia implant models when using an X-ray.
